ENGINEERING EXPERIMENT STATION  
BULLETIN SERIES No. 365

## EXPERIENCE IN ILLINOIS WITH JOINTS IN CONCRETE PAVEMENTS

A REPORT OF INVESTIGATIONS

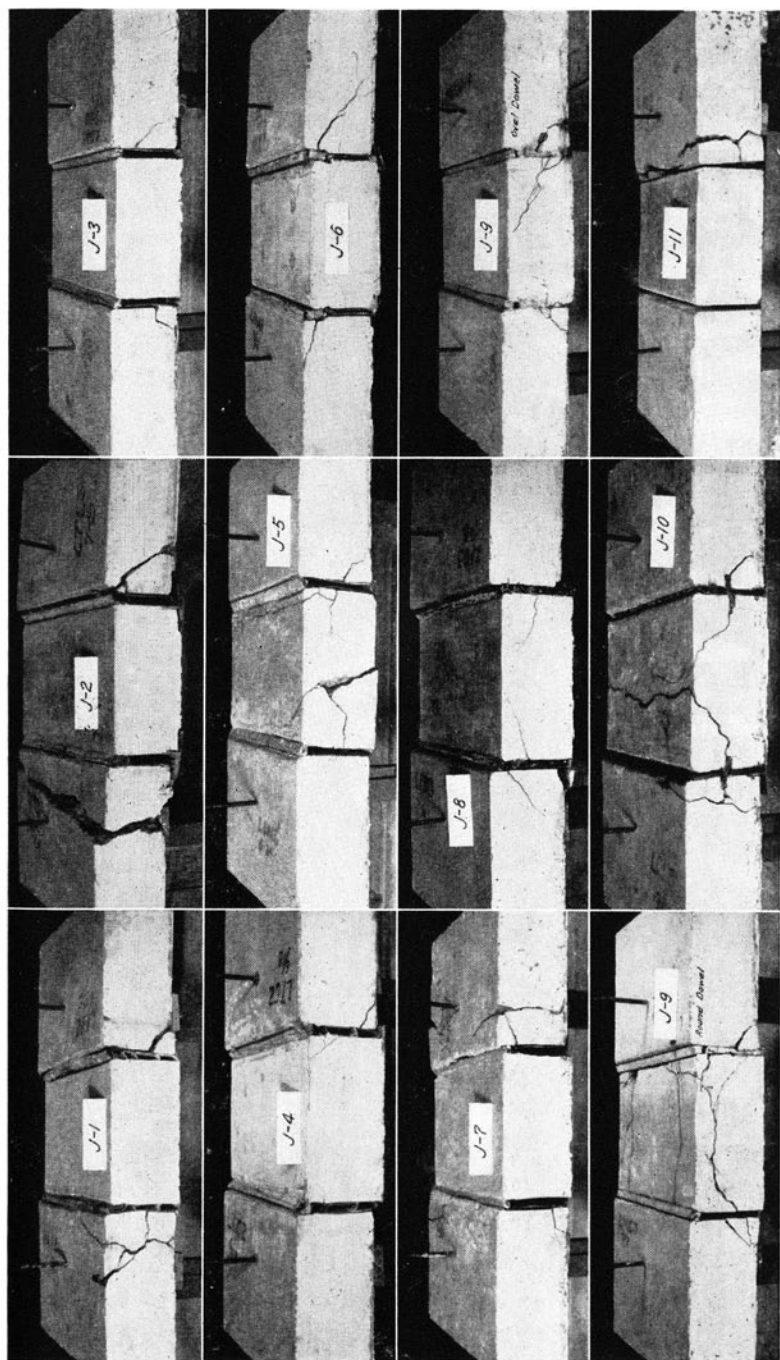
FIG. 52. JOINTS AFTER FAILURE IN LOAD TRANSFER TESTS (UNIVERSITY OF ILLINOIS TESTS)

A detailed statement as to the manner of failure of each slab and sketches showing the location of cracks are on file with the original test data. Typical failures of some of the slabs are shown in Fig. 52. A few notes regarding the manner of failure of the test slabs are given below. The slabs are identified by the type of load transmission device used.

*Conventional Dowel with J-4 Expansion Joint.* These joints were equipped with conventional  $\frac{3}{4}$ -in. round dowels, 24 in. long. The specimens failed by diagonal fractures of the upper corners of the middle slab next to the joint and above the copper seal, and the lower corners of the outer slabs. Bending of dowels and crushing of concrete were also noted.

*Conventional Dowel with J-8 Expansion Joint.* This joint was equipped with  $\frac{3}{4}$ -in. round dowels, 24 in. long. In the tests of these specimens there was little cracking until the maximum load was approached. Generally, failure was due to bending of the dowels and crushing and breaking of concrete beneath the dowels in the end slabs.

*L-1 with J-1 Expansion Joint.* There were few cracks in these slabs until the maximum load was approached. The specimens failed generally through horizontal splitting of an end slab and cracking through to the top because of the prying effect of the load transmission device. Frequently a corner or portion of the slab adjoining the joint was split off.

*L-1 with J-5 Expansion Joint.* The failure of these slabs was similar to that of the L-1 with J-1 expansion joint slabs. Cracking usually started in the plane of the load transmission devices or the copper seal. General cracking followed as failure was approached, principally in the region of load transmission devices, which in some cases seemed to split the slab in a horizontal plane.

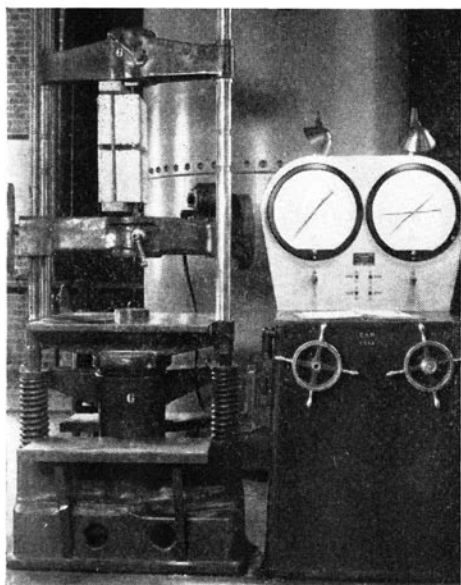
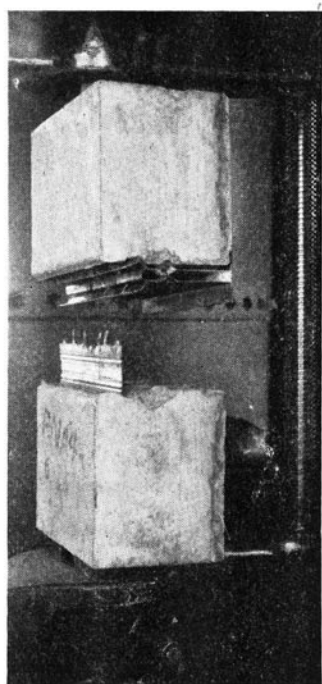
FIG. 55. ARRANGEMENT OF PULL-OUT TESTS OF COPPER SEALS. (a) ARRANGEMENT OF TEST PIECE IN TESTING MACHINE (CLAMP SHOWN IS FOR HANDLING TEST PIECE); (b) TEST PIECE AFTER FAILURE OF SEAL (UNIVERSITY OF ILLINOIS TESTS)

Figure 55 shows the arrangement of a pull-out test in a testing machine. The slab, 12 in. wide and 7 in. thick, was set vertically in the machine. A pull was applied to the lower block, in line with the plane of the copper seal anchors, and the joint was pulled apart until the copper pulled out of the concrete or broke. The loads required to produce significant action of the joint were recorded.

The tests may also indicate other weaknesses of the sealed joint, such as honeycombed concrete beneath the wings of the seal, or a weakness in the thin ledge of concrete just above the seals. Another feature of certain seals is suggested by these tests; viz., when the seal anchors consist of combined layers of copper and steel, the permanent resistance of the anchorage to corrosion is doubtful.

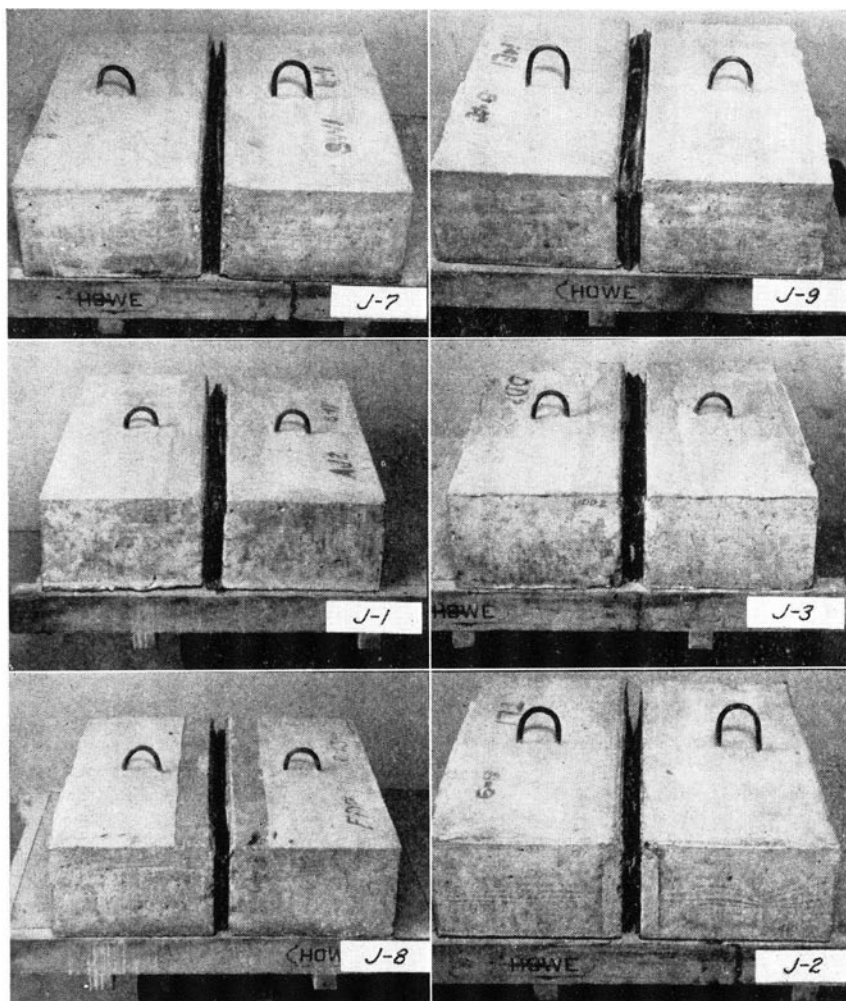
FIG. 57. TYPICAL JOINTS AFTER OPENING-CLOSING TESTS  
(UNIVERSITY OF ILLINOIS TESTS)

*J-5.* This copper seal, which like that on the J-4 joint was of the M-type, failed completely within 60 cycles of test. The principal cracks occurred at the junction between seal and concrete slab. Apparently the seal was made of a hard grade of copper or was bent too sharply at the junction noted above, judging from the speed with which the failures developed.

*J-3.* This joint had a copper seal of the M-type. The construction of the joint permitted some mortar to leak into the air chamber during concreting. Generally the cracks in the copper were small during the first 40 cycles of test; however, they developed to complete failure during the next 100 cycles. The failures were similar to those of the J-4 joints, with cracks running along the top folds of the M-section.

Views of a few of the previously discussed test pieces after failure of the copper seals are given in Fig. 57.

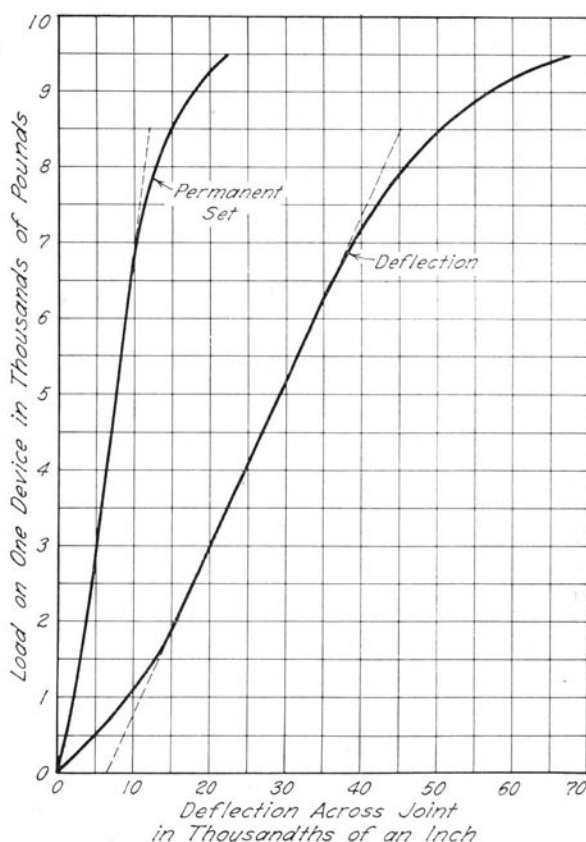
FIG. 61. AVERAGE LOAD DEFLECTION AND PERMANENT SET CURVES FOR L-1 LOAD TRANSMISSION DEVICE (ILLINOIS DIVISION OF HIGHWAYS TESTS)

Referring to Fig. 61, it will be seen that both the deflection curve and the permanent set curve have the same general shape, the former having a flatter slope and its changes in curvature being more pronounced. Beginning at the origin, the load deflection ratio is relatively low, gradually increasing up to a load of 2,000 lb., from whence it remains constant up to a load of approximately 6,500 lb., from which point the load deflection ratio, or the slope of the curve, uniformly decreases up to approximately 9,500 lb., the average load at which the concrete test specimens failed.

ticularly characteristic of devices such as the wing anchor, which consist of a bar fitted into a metal socket. Devices such as the conventional dowel bar, when the bar is embedded directly in the concrete, do not always exhibit this lost motion, especially when the concrete is properly compacted around the bar. Where the curve indicates lost motion and a considerable portion of the curve lies in a straight line, as is the case in Fig. 61, the effective amount of lost motion can be determined by extending the straight line part of the curve to the abscissa and reading the deflection at the point of intersection. The lost motion indicated in Fig. 61 is 0.0065 in.

For a considerable range in load, as indicated by the constant slope portion of the curve, elastic deformations occur, and it may be assumed that, so long as the loads which a device is required to carry in service are below the upper limit of this range, the device will not be damaged, provided of course that constant repetition of these loads does not introduce other factors. The upper limit of this range, or the point at which the deflection is no longer proportional to the load, may be called the elastic limit, as it is the point at which definite elastic failure begins. The elastic limit for the L-1 device, as shown in Fig. 61, is approximately 6,500 lb. It is interesting to note that both the load deflection curve and the load permanent set curve are in close agreement in this respect. Obviously, the elastic limit must be higher than the load which the device may be required to transmit, in order for the device to be satisfactory, and the greater the difference between the two the greater the margin of safety of the device.

Having determined the elastic limit of a device and computed the probable load transfer, one may compute the safety factor by dividing the elastic limit by the load transfer. For the L-1 device this is 6,500 divided by 2,596, which equals 2.50. The safety factor with respect to concrete failure is 9,500 divided by 2,596, or 3.66. The percentage of an 8,000-lb. static wheel load which the L-1 device may be required to transfer under assumed conditions has already been shown to be 32.4.

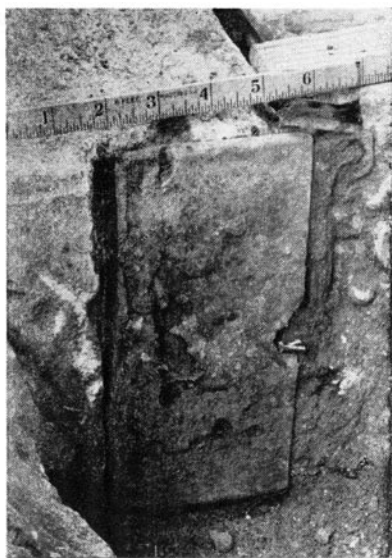
FIG. 71 (ABOVE, AT LEFT). TYPICAL EXAMPLE OF FRACTURED END SEAL ON J-1 EXPANSION JOINT

J-2 contraction joints used a seal shaped as shown in the photograph, and the failure is typical for a top seal of this design. A split end seal on a J-1 expansion joint is shown in Fig. 71. Figure 72 is typical of the condition of the galvanized end sleeves on J-2 expansion joints, and a typical example of the failure of end seals on J-4 expansion joints is shown in Fig. 73.

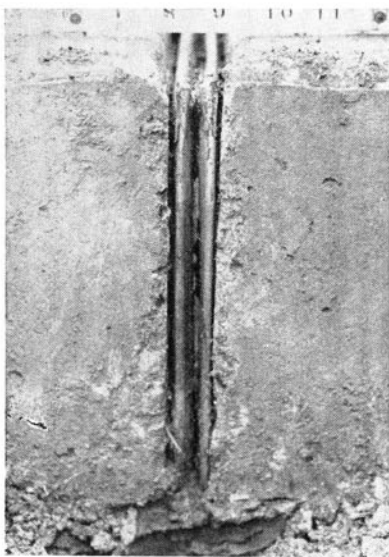
FIG. 72 (ABOVE, AT RIGHT). TYPICAL CONDITION OF GALVANIZED END SLEEVE ON J-2 EXPANSION JOINT

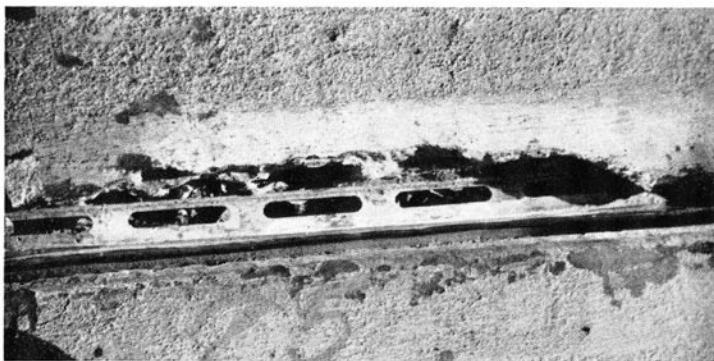
Figure 76 shows bad spalling along a J-2 expansion joint, another example of the result of poorly consolidated concrete under the flange of the seal. A case of slight spalling along a J-4 expansion joint is shown in Fig. 77. Figure 78 shows bad spalling along a J-4 contraction joint, caused by improper compaction of the concrete. A typical example of slight spalling along a 4-in. open joint is shown in Fig. 79.

FIG. 76 (AT LEFT). BAD SPALLING  
ALONG J-2 EXPANSION JOINT

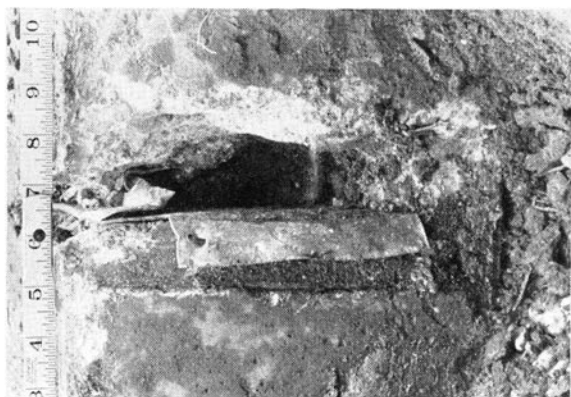
FIG. 88  
TYPICAL EXAMPLE OF DIRT  
IN J-2 EXPANSION JOINT

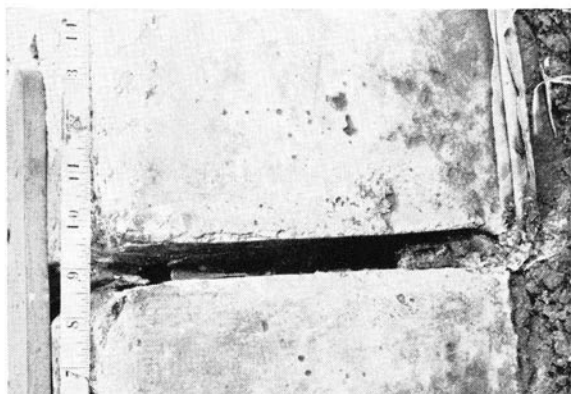
FIG. 89  
TYPICAL EXAMPLE OF DIRT  
IN J-4 EXPANSION JOINT

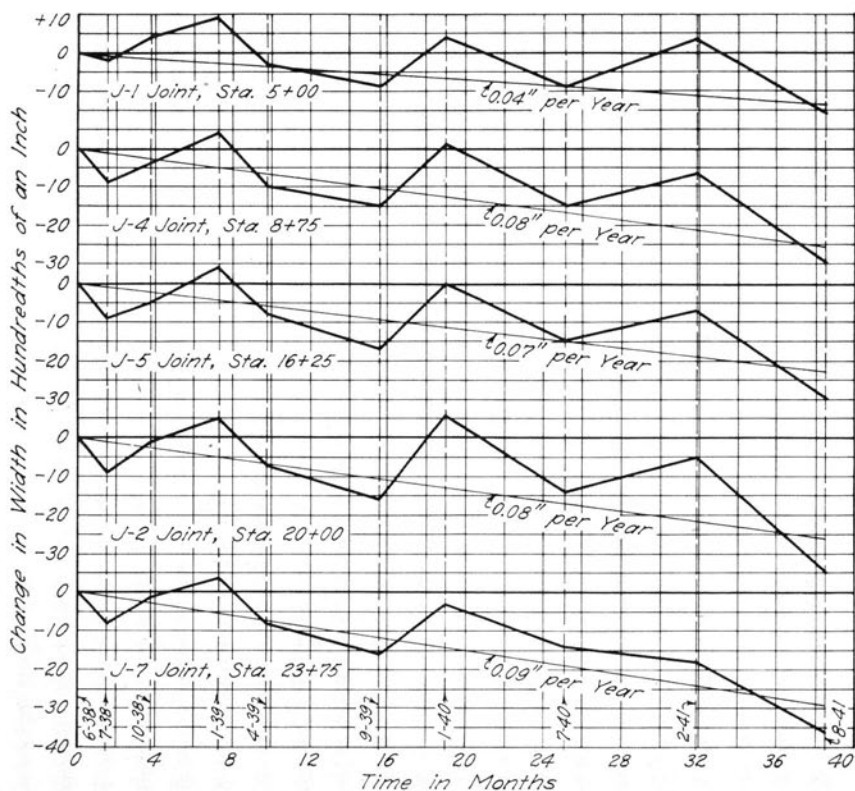
FIG. 93. CHANGE IN WIDTH OF 1-IN. METAL EXPANSION JOINTS INSTALLED AT 75-FT. INTERVALS WITH TWO INTERVENING CONTRACTION JOINTS FORMING 25-FT. PANELS

open and close uniform amounts, the movement being more at some joints than at others. This variation in joint behavior is significant, as it may have an important bearing on the formation of cracks, blowups, and other failures. The reason for unequal movements at joints was not ascertained, but it probably was due principally to differences in internal resistance within the joints caused by the load transmission devices and the presence or absence of joint filler. This is indicated by the fact that most of the premolded type joints showed smaller movements than the metal joints, which were designed to provide a substantially free expansion space.

Figures 93 to 97 also show that many of the expansion joints have developed an appreciable amount of permanent closure; that is, the joint opening is becoming smaller as the age of the pavement increases. In these cases, the approximate average rate of closure for the three-year period was estimated by plotting by inspection an average straight line for the various points on the curve.

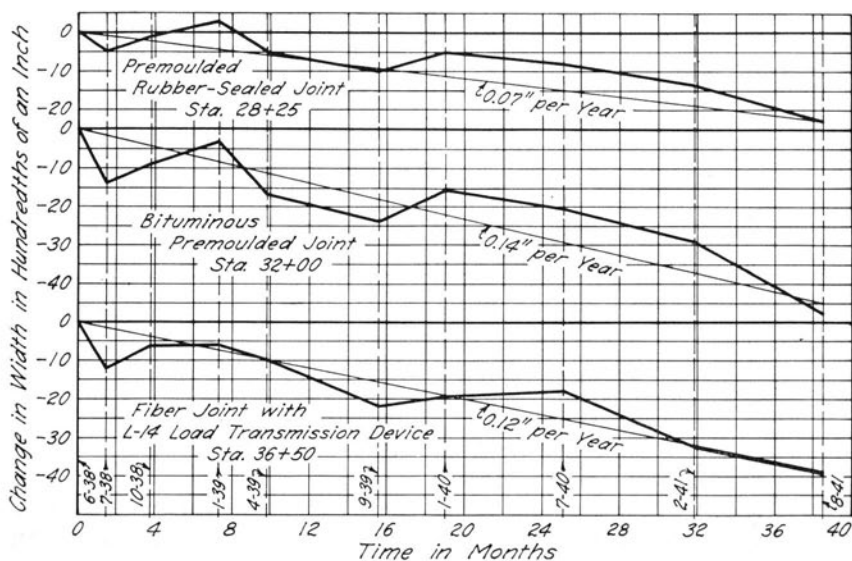
FIG. 94. CHANGE IN WIDTH OF 1-IN. PREFORMED EXPANSION JOINTS INSTALLED AT 75-FT. INTERVALS WITH TWO INTERVENING CONTRACTION JOINTS FORMING 25-FT. PANELS

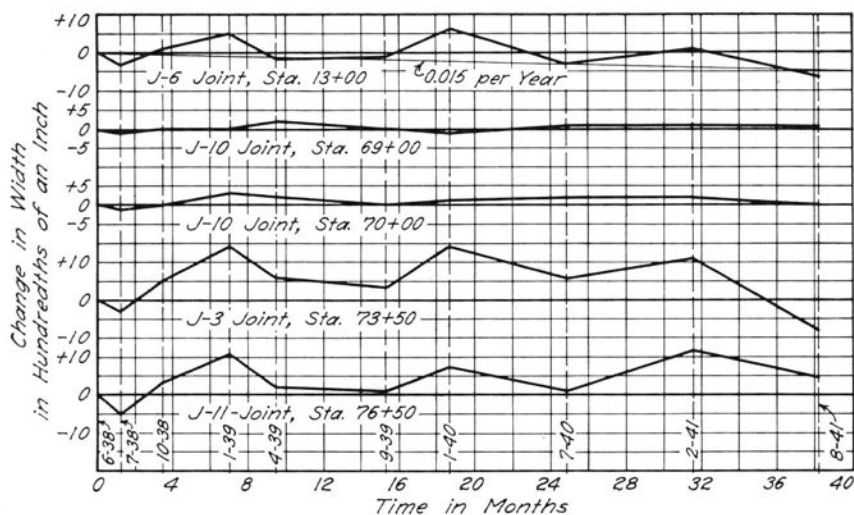
FIG. 95. CHANGE IN WIDTH OF  $\frac{1}{2}$ -IN. EXPANSION JOINTS  
INSTALLED AT 25-FT. INTERVALS

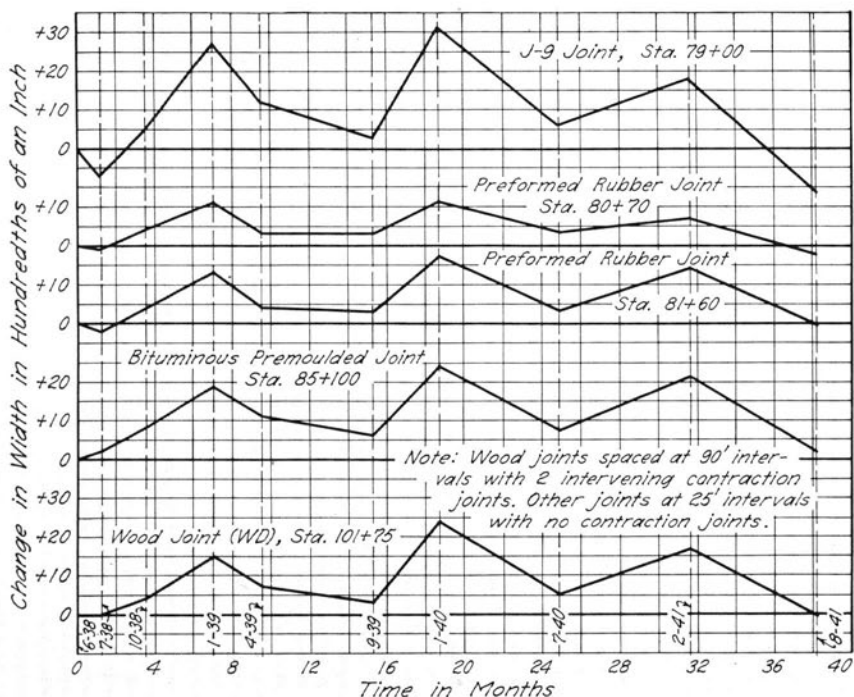
FIG. 96. CHANGE IN WIDTH OF  $\frac{1}{2}$ -IN. PREFORMED EXPANSION JOINTS  
INSTALLED AT 25 AND 30-FT. INTERVALS

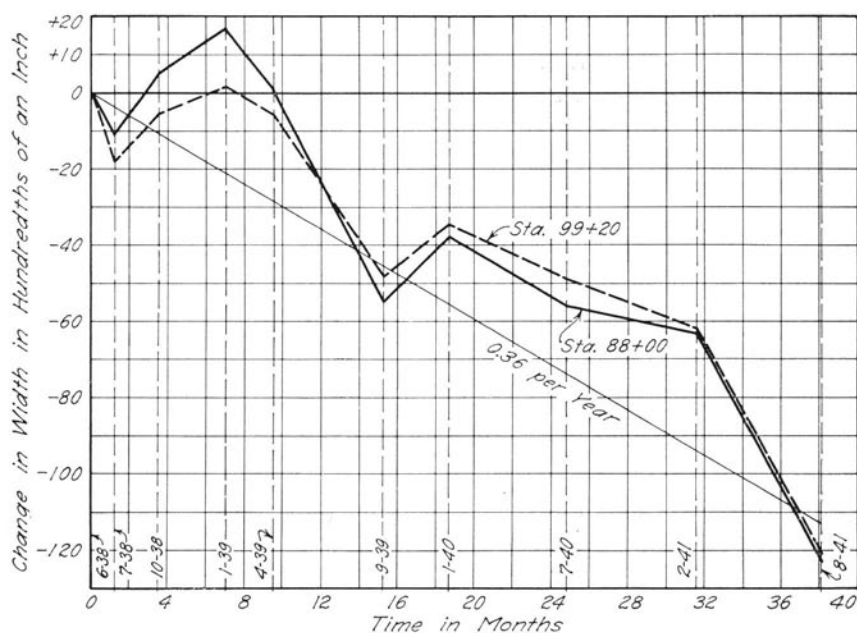
FIG. 97. CHANGE IN WIDTH OF 4-IN. OPEN JOINT

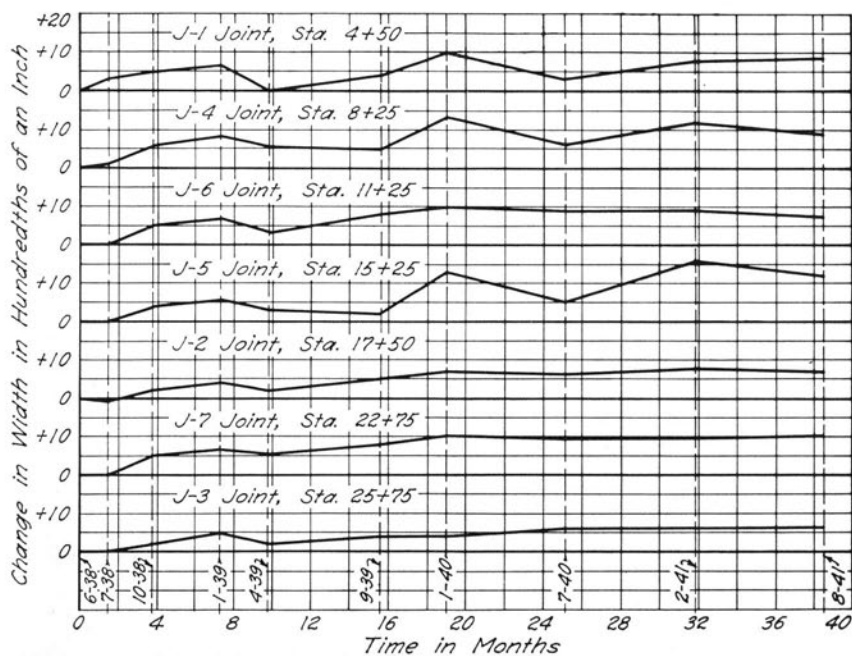
Typical examples of the movement in contraction joints are shown in Figs. 98 to 100, inclusive. Movements in seven representative metal contraction joints are shown in Fig. 98. Figures 99 and 100 give

FIG. 98. CHANGE IN WIDTH OF METAL CONTRACTION JOINTS

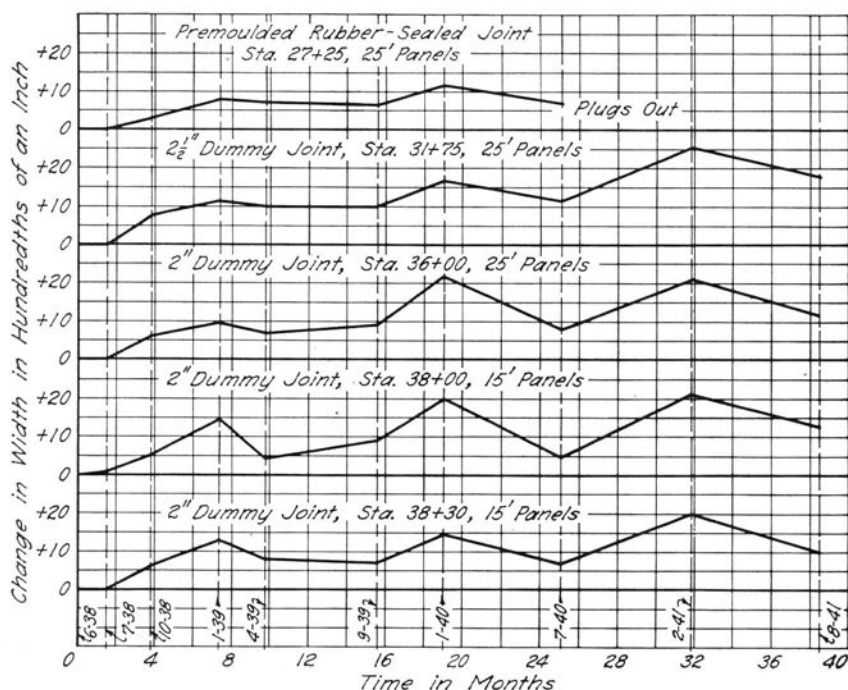
FIG. 99. CHANGE IN WIDTH OF DUMMY CONTRACTION JOINTS INSTALLED AT 15 AND 25-FT. INTERVALS

similar data for 12 dummy contraction joints. The five joints covered by Fig. 99 were installed in conjunction with 1-in. expansion joints, two dummy contraction joints between each pair of expansion joints. The seven dummy joints included in Fig. 100 were installed without intervening expansion joints.

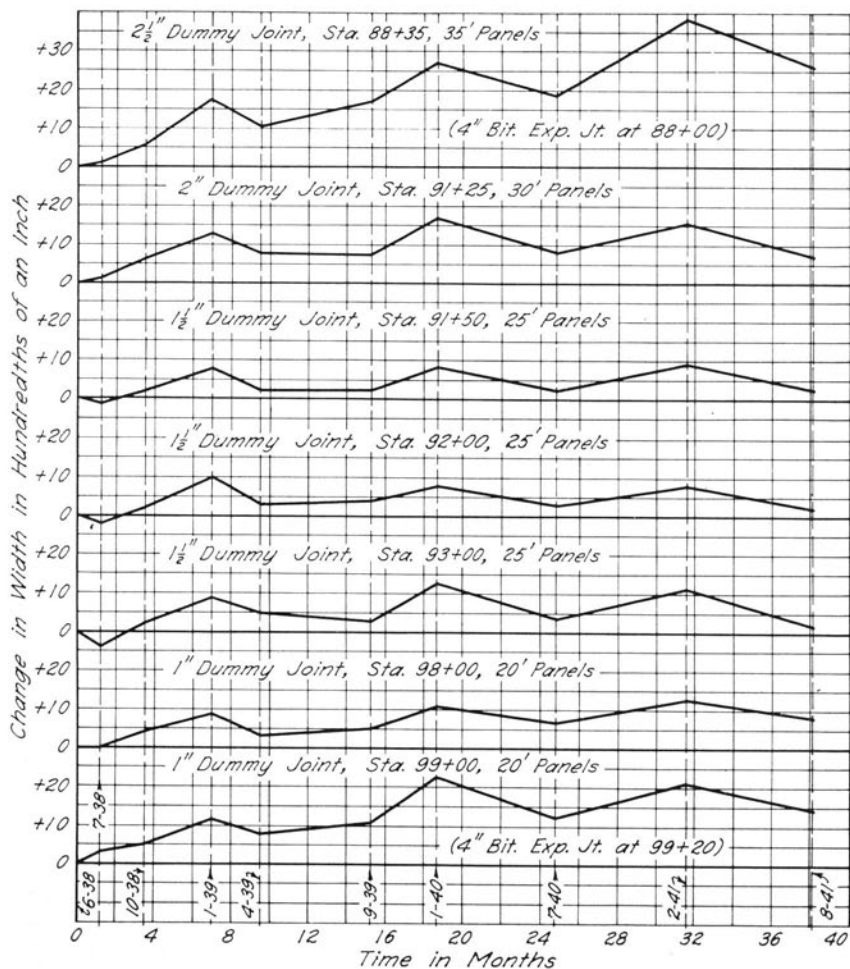
As in the case of expansion joints, the movements in contraction joints also were not uniform, those at some joints being greater than at others. The unusually large movement in the dummy joint at Sta. 88 + 35 was probably influenced by the large permanent closure of

FIG. 100. CHANGE IN WIDTH OF DUMMY CONTRACTION JOINTS INSTALLED AT 20, 25, 30, AND 35-FT. INTERVALS WITH NO INTERVENING EXPANSION JOINTS

the 4-in. open joint at Sta. 88 + 00, only 35 ft. away. Measurements made on August 16, 1944, indicated that the opening of dummy contraction joints immediately adjacent to the 4-in. open joints at Sta. 99 + 20 and Sta. 88 + 00 were from two to three times greater than the opening of the dummy joints farther away from the expansion joints. This effect was apparent only 100 ft. on each side of the expansion joints, the openings in the middle part of the section being approximately equal for all joints.

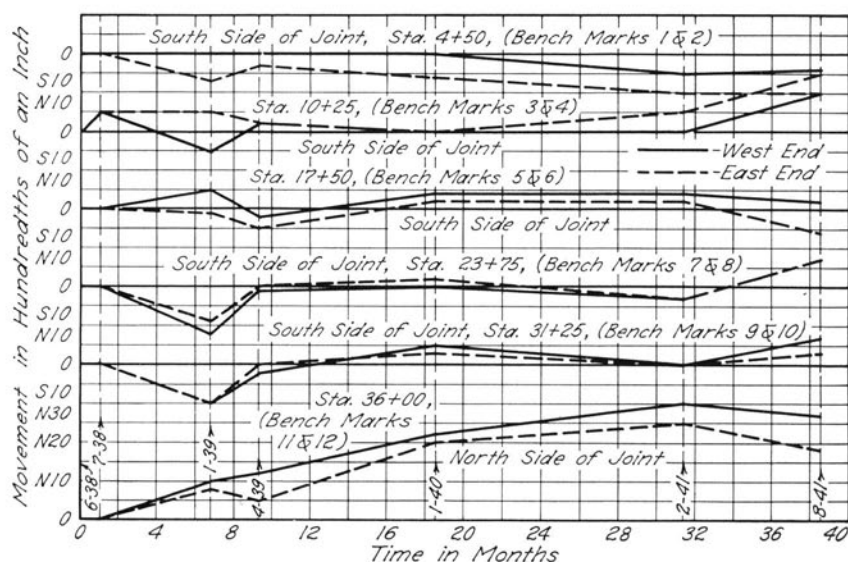
It appears that permanent movements of some of the slabs occurred over the three-year period during which readings are available. For example, Fig. 101 shows that in August, 1941, the slab on the north side of the joint at Sta. 36 + 00 was approximately 0.25 in. north of its original position determined in June, 1938.

FIG. 101. HORIZONTAL MOVEMENT OF SLABS ADJACENT TO JOINTS WITH REFERENCE TO BENCH MARKS

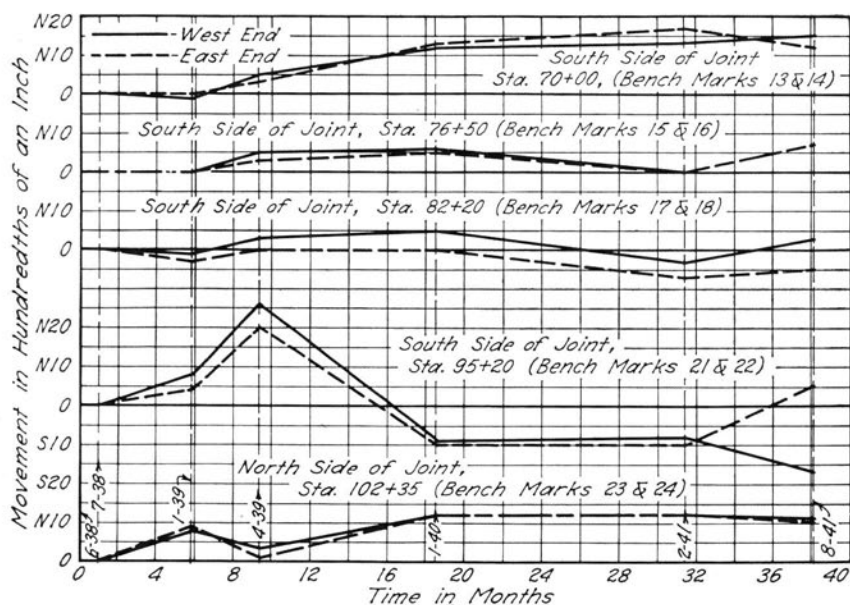
In August, 1941, the slab on the south side of the joint at Sta. 70 + 00 was approximately 0.15 in. north of its original position, also determined in June, 1938 (Fig. 102). It is interesting to note that the movement at Sta. 36 + 00 was upgrade, while the movement at Sta. 70 + 00 was downgrade.

FIG. 102. HORIZONTAL MOVEMENT OF SLABS ADJACENT TO JOINTS WITH REFERENCE TO BENCH MARKS

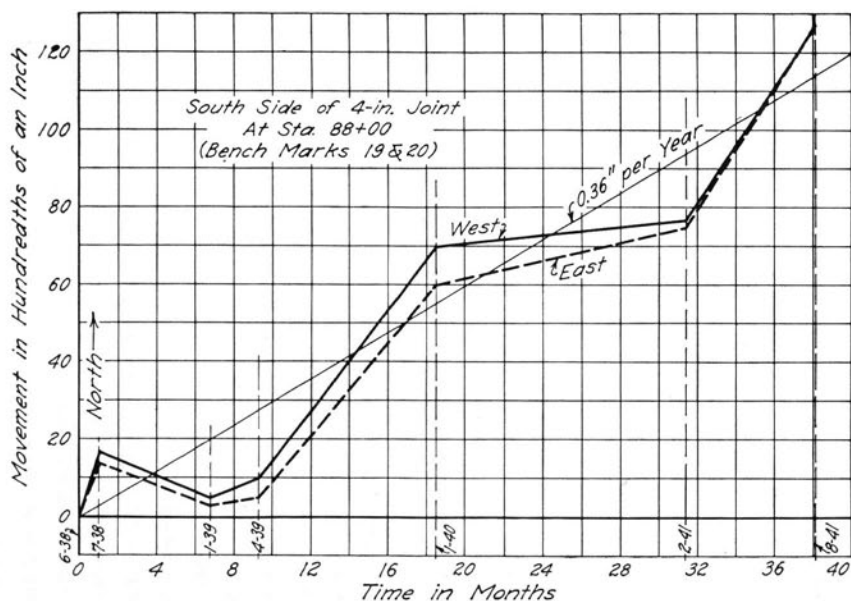
The greatest movement recorded for any slab was on the south side of the 4-in. open joint at Sta. 88 + 00. Figure 103 shows an apparent permanent movement of approximately 1.27 in. northward, which is upgrade. A possible explanation is that the point measured is the north end of a section of pavement 1,120 ft. long, which contains dummy contraction joints at 20- to 35-ft. spacings and has no provision for taking up expansion and permanent movements except the 4-in. open expansion joints at each end. When this fact is considered, it is reasonable to expect a large permanent movement at the 4-in. joints. It is unfortunate that similar measurements were not made at Sta. 99 + 20, the other end of the 1,120-ft. section of pavement, between the two 4-in. joints.

FIG. 103. HORIZONTAL MOVEMENT OF SLAB ADJACENT TO 4-IN. OPEN JOINT WITH REFERENCE TO BENCH MARKS

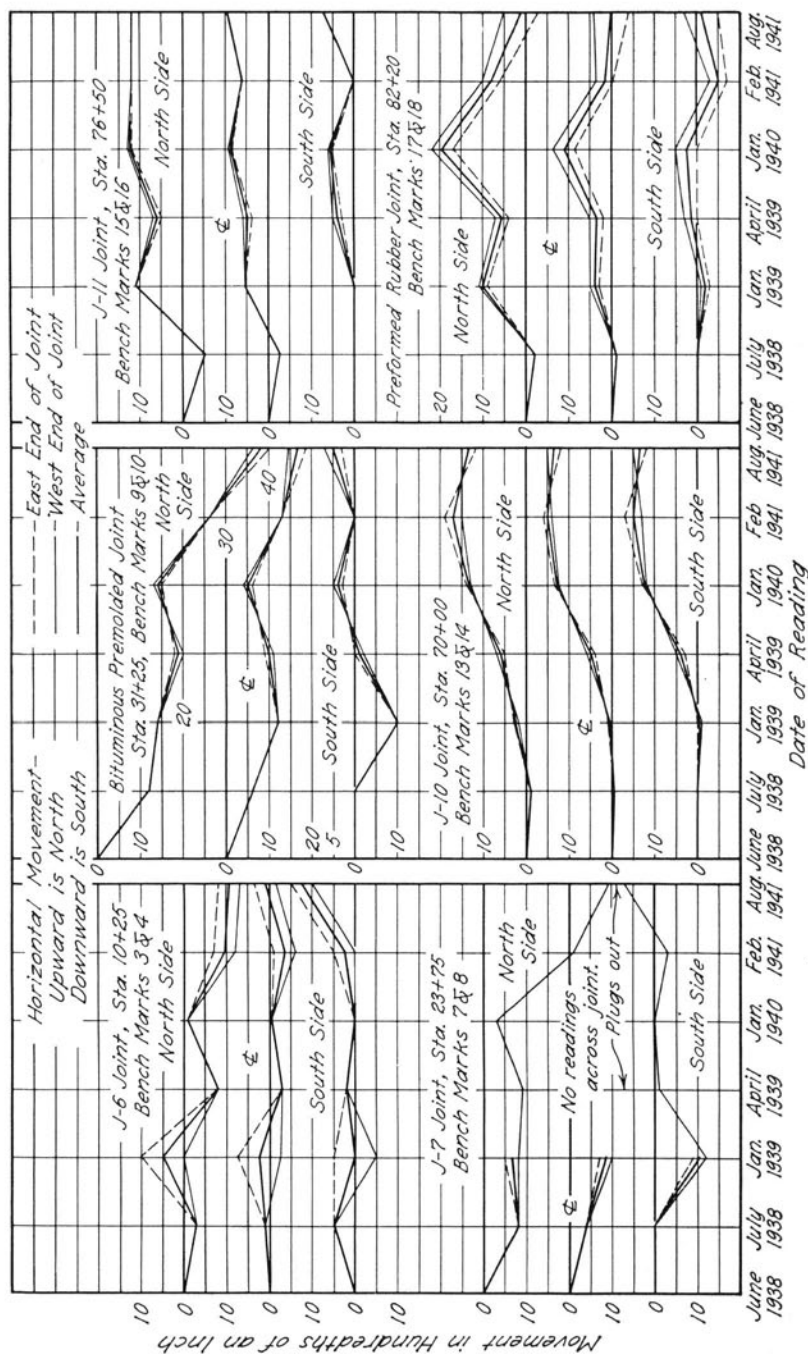
FIG. 104. HORIZONTAL MOVEMENTS OF SLAB ENDS ON EACH SIDE OF EXPANSION JOINTS AND SHIFT IN CENTERLINE OF JOINTS

105. Besides opening and closing with seasonal change in temperature, some of these joints shifted permanently from their original positions. This is apparent from the fact that the average centerline position in August, 1941, deviates considerably from the zero or original position. Examples of shift in position are the bituminous premolded joint at Sta. 31 + 25, the J-10 joint at Sta. 70 + 00, shown in Fig. 104, and the 4-in. open joint, shown in Fig. 105. The most striking example

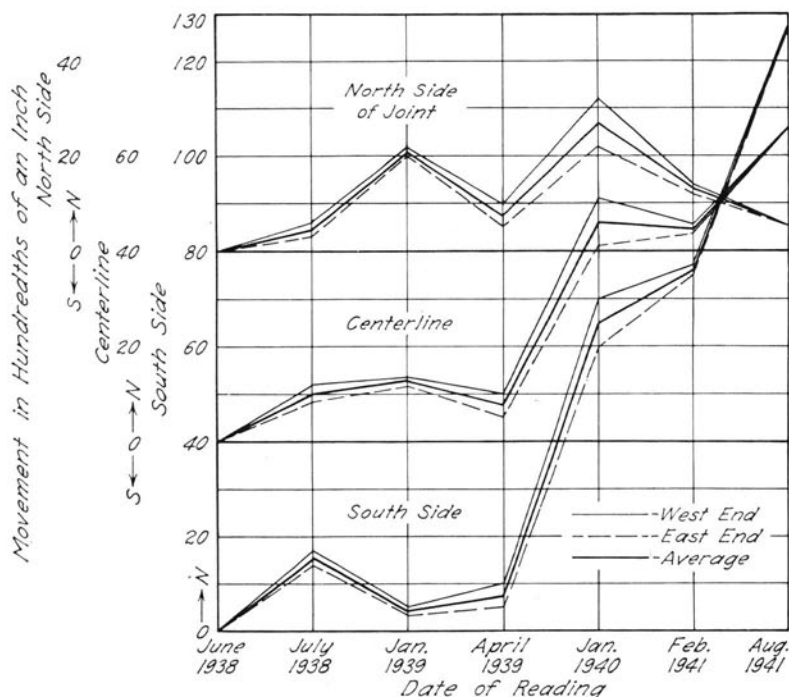
FIG. 105. HORIZONTAL MOVEMENTS OF SLAB ENDS ON EACH SIDE OF 4-IN. OPEN JOINT AT STA. 88 + 00 AND SHIFT IN CENTERLINE OF JOINT

is the latter, where the south side moved north a distance of 1.27 in., while the north side was moving 0.05 in. to the south, resulting in a permanent closure of 1.32 in. and a shift in the position of the joint centerline of 0.61 in. to the north.

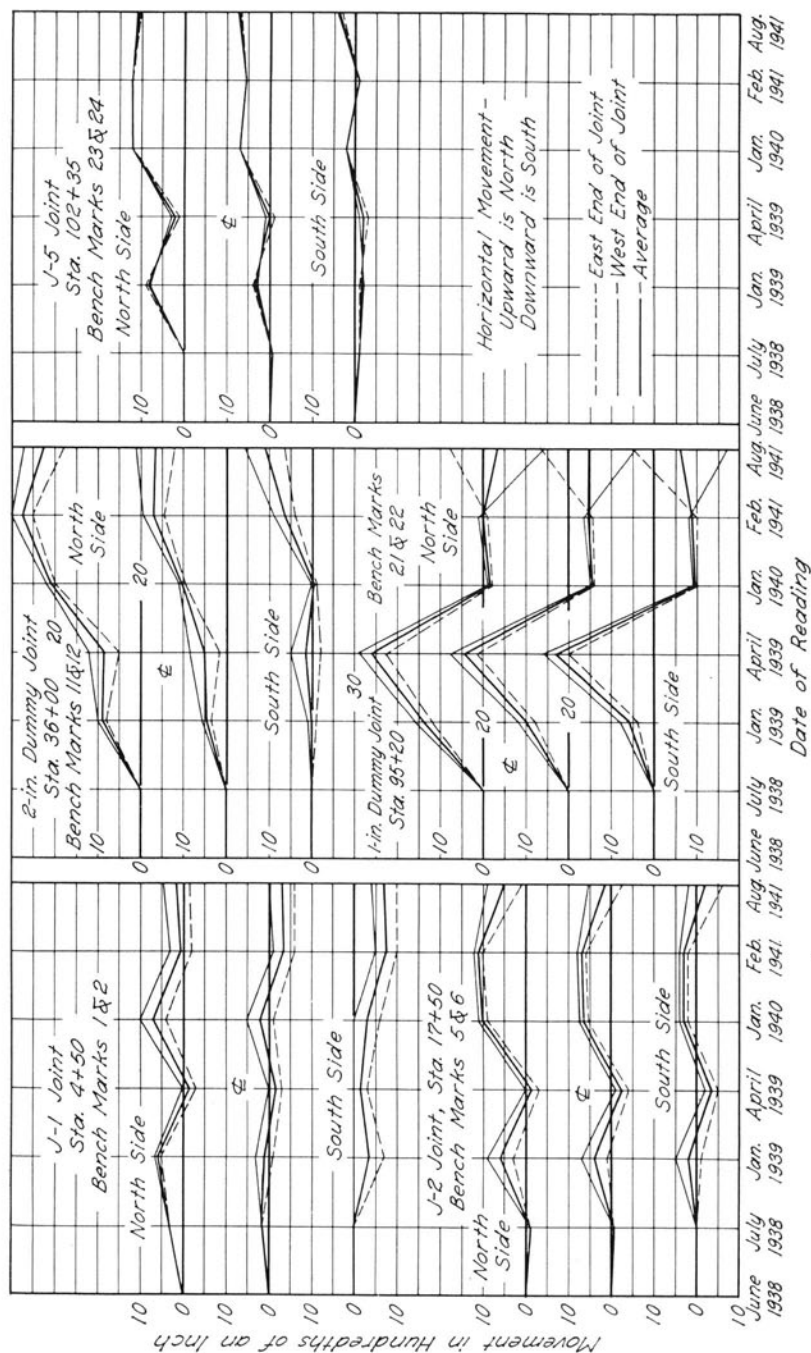
Similar movements for two selected contraction joints are shown in Fig. 106. It is seen that the movements at these joints have been minor.

FIG. 106. HORIZONTAL MOVEMENTS OF SLAB ENDS ON EACH SIDE OF CONTRACTION JOINTS AND SHIFT IN CENTERLINE OF JOINTS

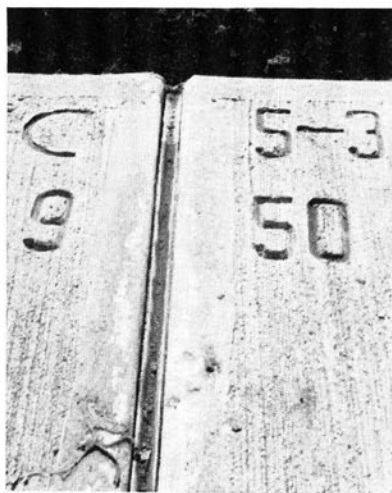
FIG. 110. J-4 EXPANSION JOINT AT STA. 9 + 50, SHOWING  
COPPER SEAL BEFORE ASPHALT CAP WAS  
POURED (JUNE, 1938)

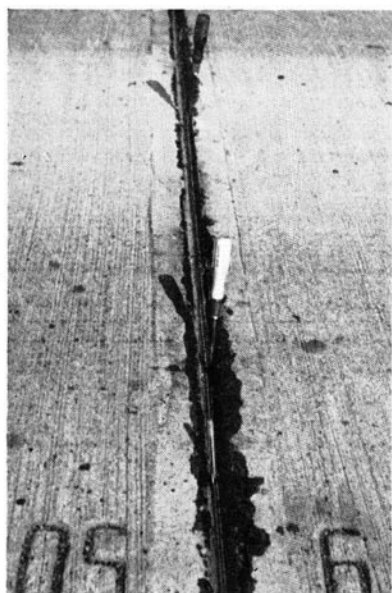
FIG. 111. J-4 EXPANSION JOINT AT STA. 9 + 50 WITH ASPHALT  
CAP PARTIALLY REMOVED, SHOWING COPPER SEAL  
CRIMPED AND SPLIT (AUGUST 25, 1941)

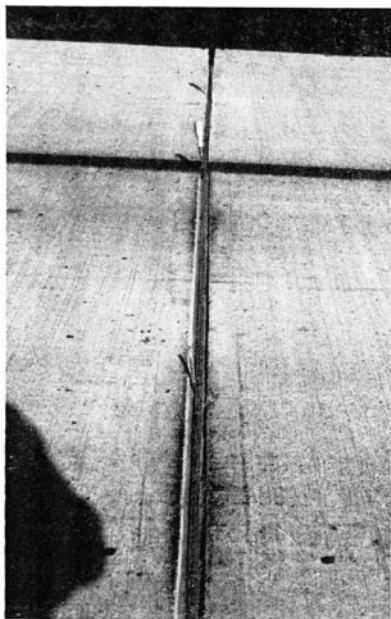
FIG. 114. J-7 EXPANSION JOINT AT STA. 23 + 00 WITH ASPHALT CAP REMOVED, SHOWING LONG SPLIT IN COPPER SEAL (AUGUST 25, 1941)

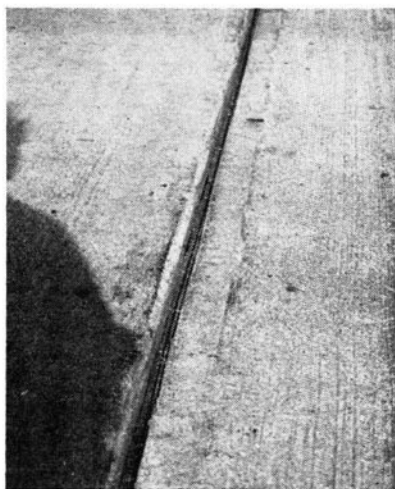
FIG. 115. J-3 EXPANSION JOINT AT STA. 25 + 50 WITH ASPHALT CAP REMOVED, SHOWING SPLITS IN COPPER SEAL (AUGUST 25, 1941)

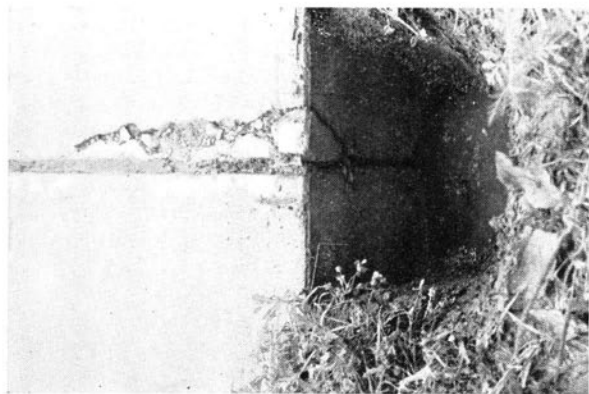
FIG. 117

117. J-10 Expansion Joint at Sta. 69+25, Showing Failure in Concrete Slab Induced by Plate Dowel (July 23, 1941) . . . . .	228
118. Same Joint as in Fig. 117, with Shattered Concrete Removed (July 23, 1941). This Failure Is Typical of Those Produced in Laboratory Tests of This Type of Joint . . . . .	228

FIG. 117. J-10 EXPANSION JOINT AT STA. 69 + 25, SHOWING FAILURE IN CONCRETE SLAB INDUCED BY PLATE DOWEL (JULY 23, 1941)

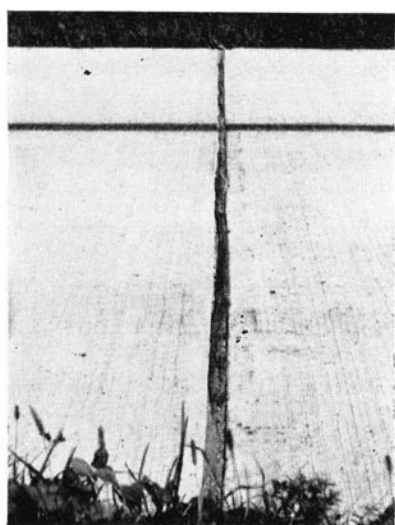
FIG. 120. J-11 EXPANSION JOINT AT STA. 76 + 25. METAL SIDE PLATES DID NOT REMAIN TIGHT AGAINST FILLER, PERMITTING DIRT TO ENTER BETWEEN THEM AND ACCUMULATE IN EXTRUSION CHAMBERS (AUGUST 25, 1941)

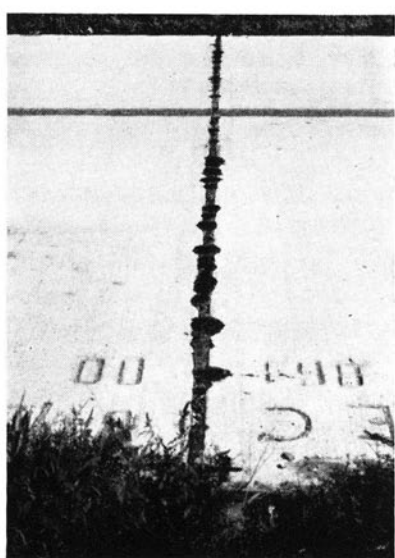
122. Bituminous Premolded Expansion Joint at Sta. 86+00, Showing Slight Extrusion. Filler in Good Condition (August 25, 1941) . . . . .	229
123. Bituminous Premolded Expansion Joint at Sta. 83+00, Showing Excessive Extrusion Caused by Pouring Asphalt Seal on Top of Joint. Compare with Joint without Seal in Fig. 122 (August 25, 1941) . . . . .	233

FIG. 122. BITUMINOUS PREMOLDED EXPANSION JOINT AT STA. 86 + 00, SHOWING SLIGHT EXTRUSION. FILLER IN GOOD CONDITION (AUGUST 25, 1941)

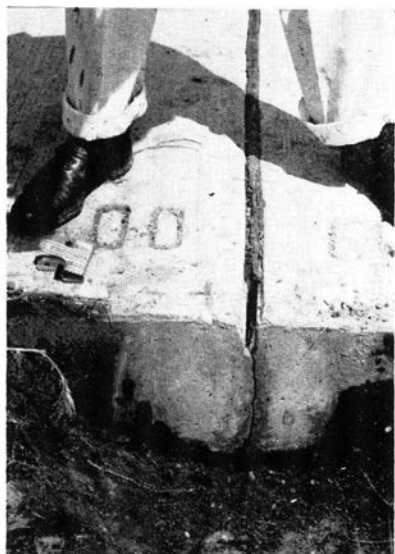
FIG. 128. DUMMY CONTRACTION JOINT AT STA. 98 + 40, SHOWING TYPICAL CRACK FORMED BY 1-IN. GROOVE (JULY 23, 1941)

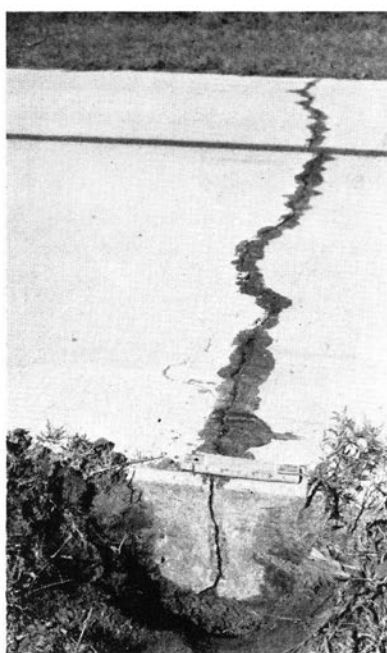
FIG. 130. TRANSVERSE CRACK AT STA. 74 + 85. CRACK OPENING IS ABOUT  $\frac{1}{4}$  IN.

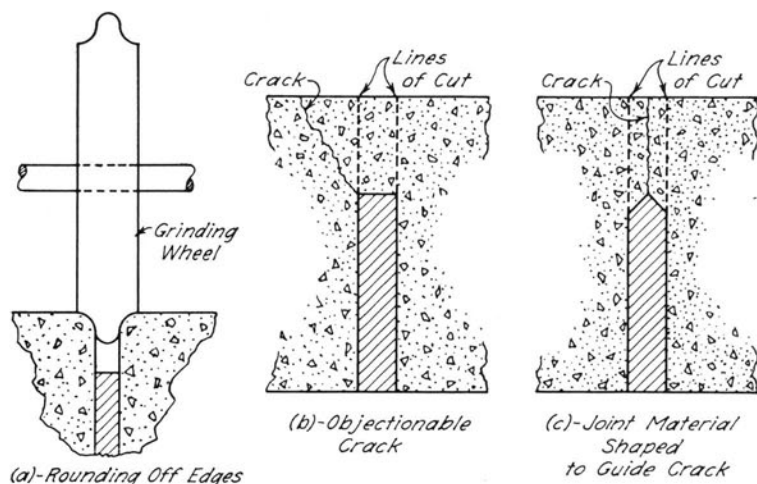
FIG. 134. POSSIBLE IMPROVEMENTS IN PROCESS FOR CUTTING JOINTS

Although it did not occur at any of the joints included in the investigation, there is a possibility that the shrinkage crack over the joint material may sometimes fall outside of the joint space, as shown in Fig. 134b, a defect which would leave spalled edges along the joint. The tendency for such objectionable cracks to form would be reduced by early cutting, and might be reduced by shaping the top of the joint material as shown in Fig. 134c.

It seems quite probable that spalling can be still further reduced by improvements in the jointing and cutting technique. Rounding off the sharp edges of the joint, as shown in Fig. 134a, should make these edges less susceptible to traffic abrasion and impact. This could be done by adding another trailer wheel of appropriate shape to the machine, or by other means.
